**SHEPHERD**  
**HOME REPORT**

FLAT 3/1  
121 SHUNA STREET  
GLASGOW  
G20 9QP

# Energy Performance Certificate (EPC)

# Scottish Single Survey

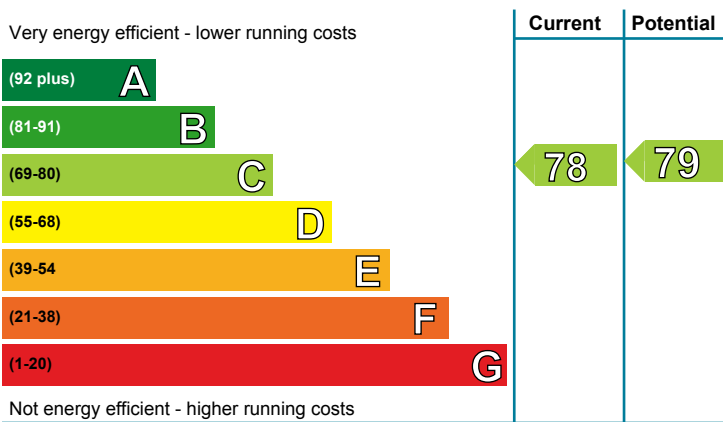
## Energy Efficiency Rating

This graph shows the current efficiency of your home, taking into account both energy efficiency and fuel costs. The higher this rating, the lower your fuel bills are likely to be.

Your current rating is **band C (78)**. The average rating for EPCs in Scotland is **band D (61)**.

The potential rating shows the effect of undertaking all of the improvement measures listed within your recommendations report.

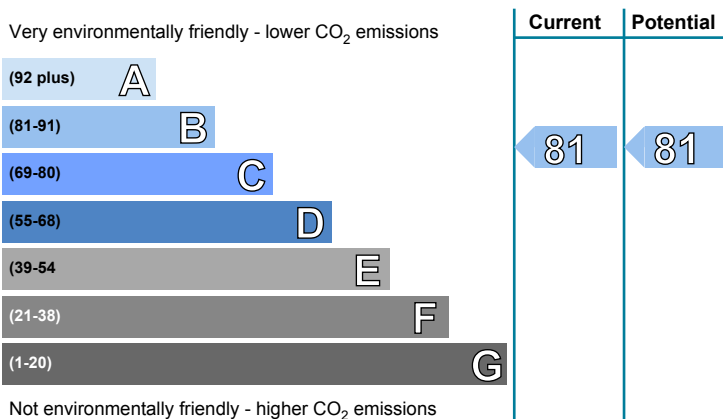
## Environmental Impact (CO<sub>2</sub>) Rating

This graph shows the effect of your home on the environment in terms of carbon dioxide (CO<sub>2</sub>) emissions. The higher the rating, the less impact it has on the environment.

Your current rating is **band B (81)**. The average rating for EPCs in Scotland is **band D (59)**.

The potential rating shows the effect of undertaking all of the improvement measures listed within your recommendations report.
